Experimental Study on Composite Beams with Circular Web Openings

ABSTRACT

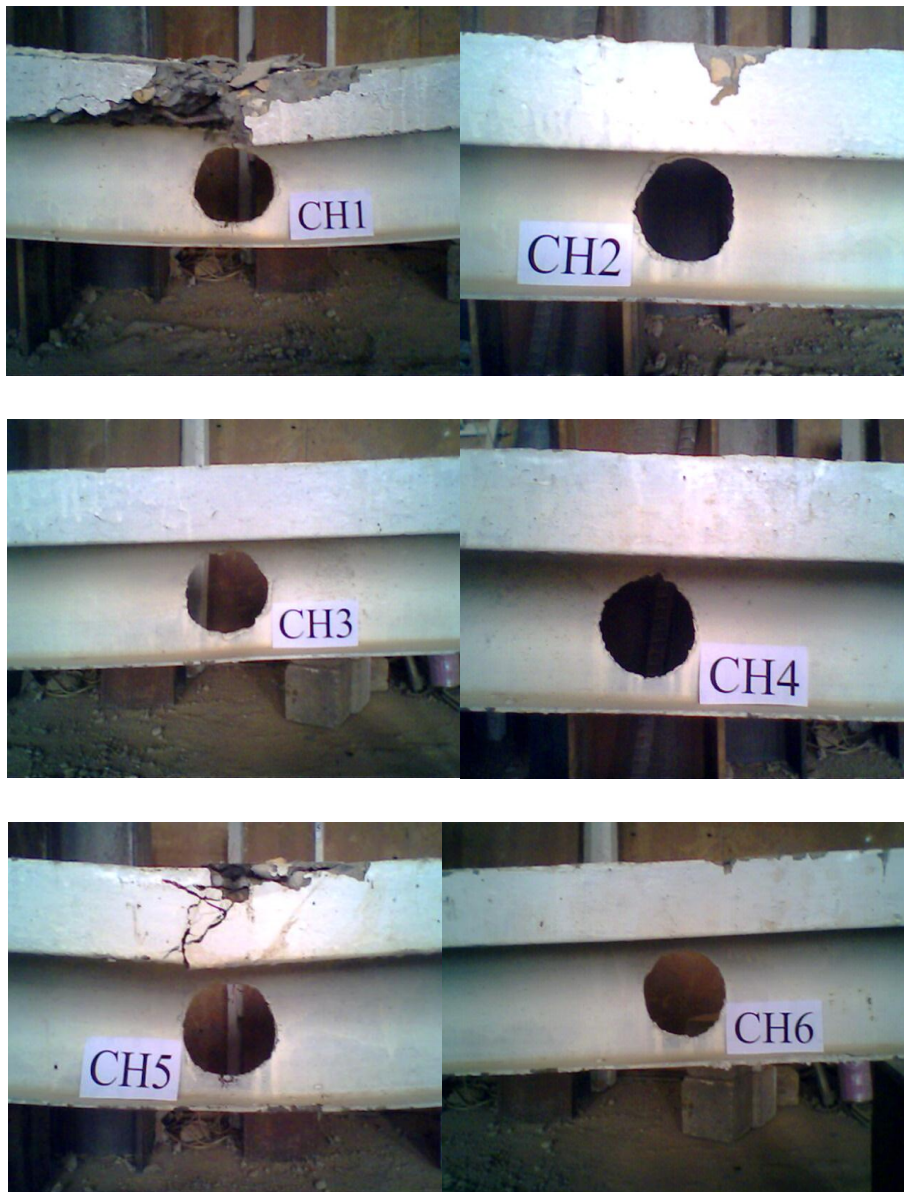
Figure (5): Openings at failure

Little increase in the deflection of opening CH2 with respect to CH3 (Beam CB2) and in CH6 with respect to CH4 (beam CB3) was observed near failure load, see Figure (5). This is due to the presence of concrete transverse cracks over openings CH2 and CH6. All openings shape at failure are shown in Figure (6).

The bottom tees of openings located at midspan were first position yielded in beams CB1 and CB3. Holes CH1 and CH5 yielded at 75% and 69% of the ultimate load, respectively. Yielding extended along the width of openings that indicates a flexure failure. Near failure, the top tees yielded also and the concrete slab over openings crushed. It can be noticed that there was a local buckling at the top tee of opening CH1.

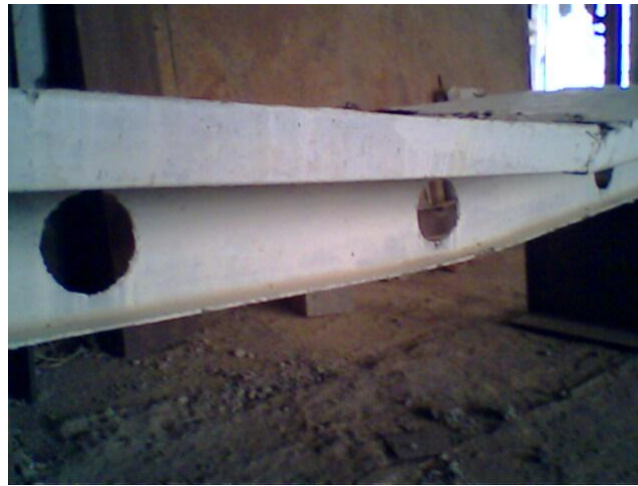
Figure (7): Typical failure mode (Beam CB3)

Failure of the composite beams was quite ductile. The reaching of ultimate loads were preceded by major cracking in the concrete, yielding of the steel section and large deflections. Yielding of steel sections at midspan (in the presence of an opening or not) was observed at load level more than 64% of the ultimate load. Yielding occurred at the tension zone or the bottom tee of steel section at opening. As the load increased, longitudinal and transverse cracking occurred within the slabs. At collapse, the concrete around shear studs at midspan failed, and the slab may be lifted (bridged) from the steel beam. Typical failure mode for composite beams (beam CB3) is shown in Figure (7).

4. The failure mode of composite beams with circular web openings is quite ductile. Failure is beginning by yielding of steel section, followed by major cracking of concrete, and then large deflection at midspan.
